### SALVADORA PROPERTY

# Overview

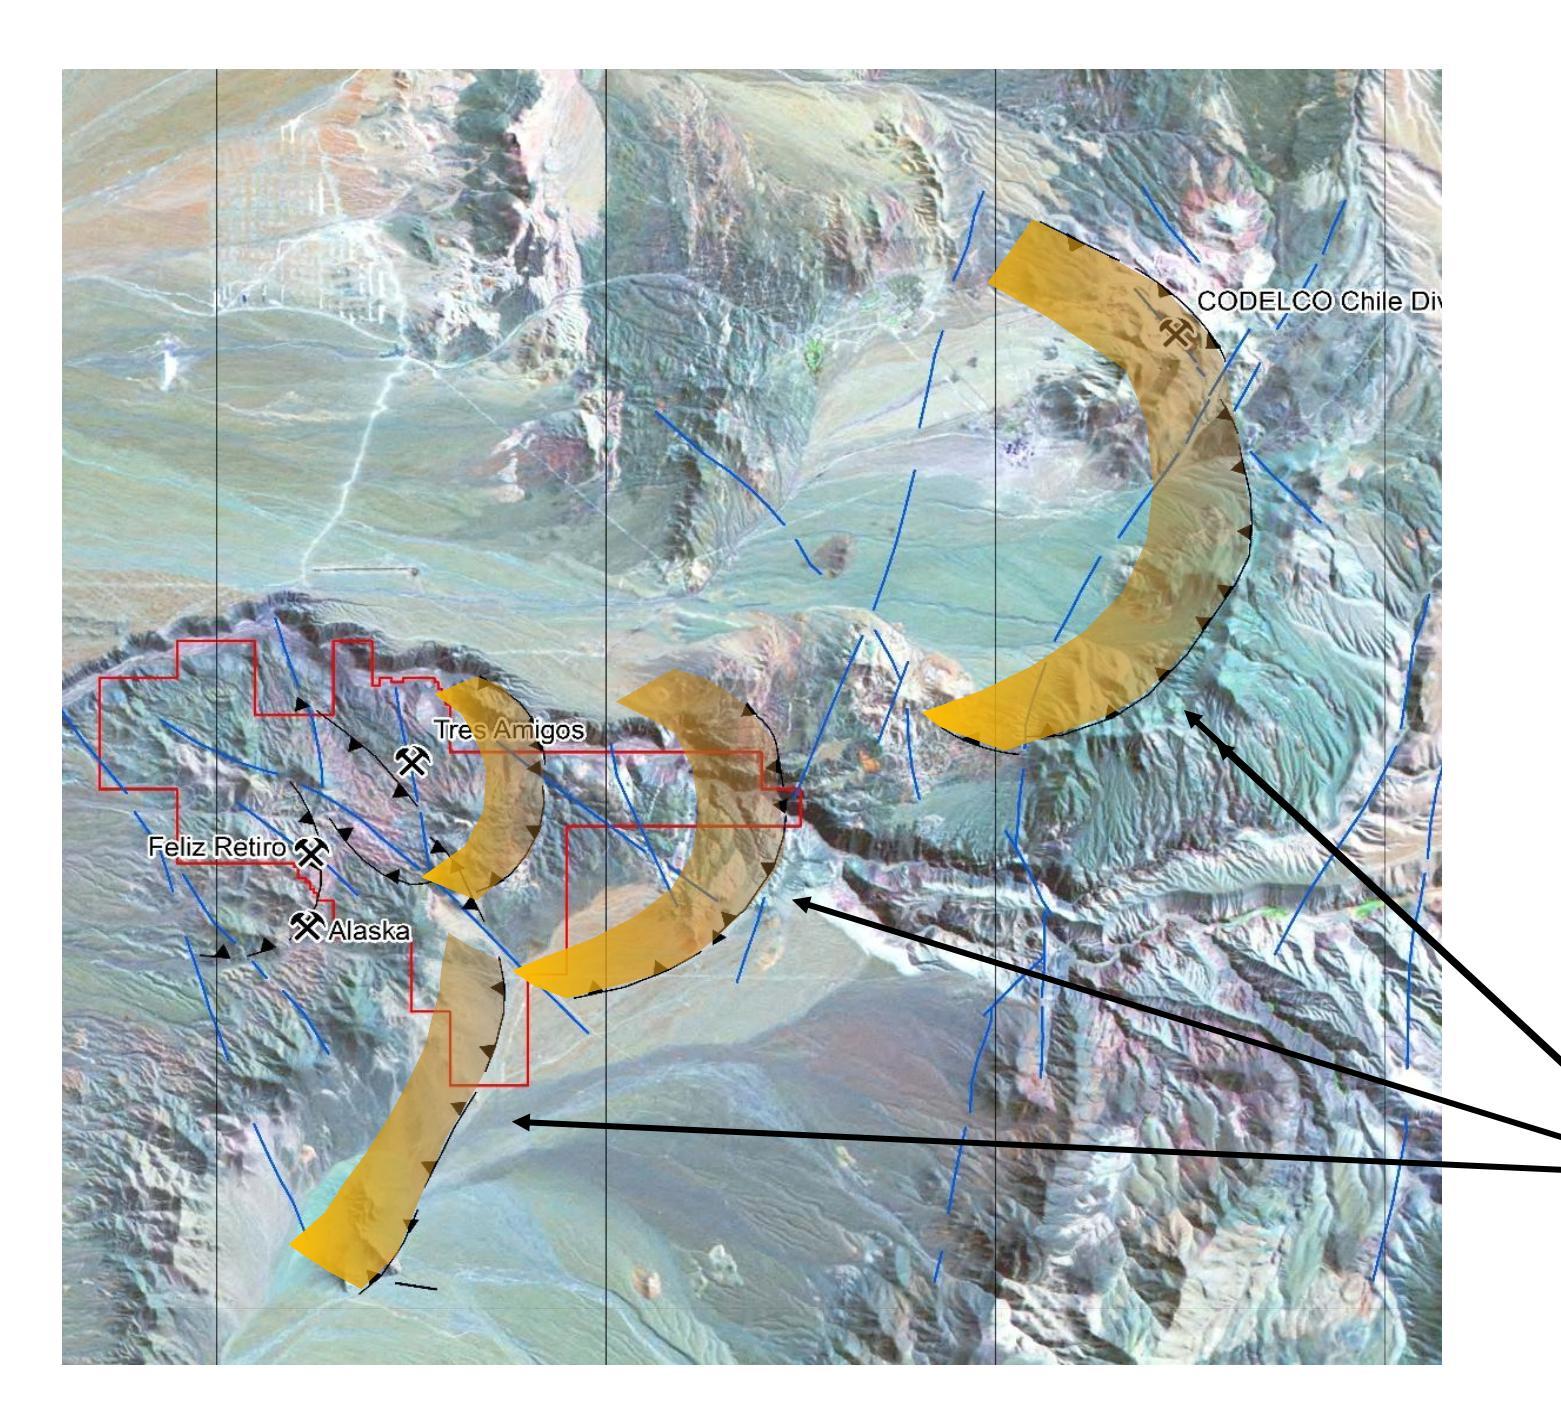
The Codelco El Salvador Mine San Lorenzo's Salvadora property are found in similar geological settings – lying within the boundaries of caldera collapse zones that subsequently underwent intrusive lifting and mineralized fluid migration – both in fractured cap rock and through fault systems caused by intrusive forces

Outer rims of caldera collapse zones
